Inspection Report

Mine Name: Golden Phoenix Claims

Permit number: S0130012

Inspection Date: September 11,

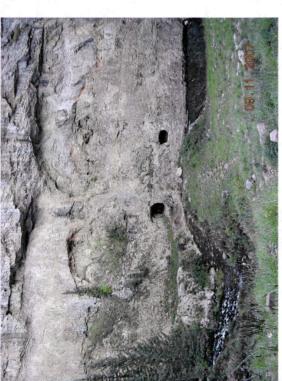
As can be seen in Photo 1, there are two openings into a limestone cliff. These openings are not fenced or otherwise closed. I walked into one of the portals for a few feet, and it loops over to connect with the other opening. I do not know how far back the workings extend but suspect it's not too far.

According to Dave Herron with the Forest Service, there is a reclaimed access road leading to the portals. Since this road is reclaimed, the only access appears to be on a foot path down a fairly steep hill.

Although the portals are open and unguarded, I do not believe they pose much of a risk to the public because the rock appears to be competent. I am checking with MSHA to see what their requirements are.

Photo 1. An overview of the mine area. There is a reclaimed road leading to the portal on the left.

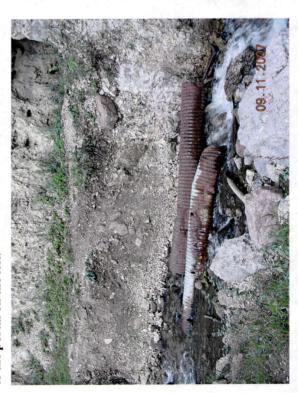
There are two culverts in the creek, but it's obvious not all the water flows through them.

Photo 2. Culverts in the stream by the upper portal.

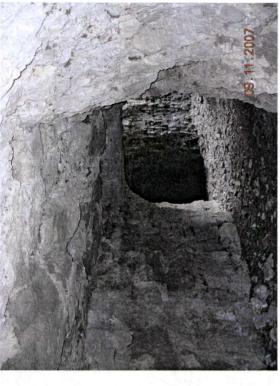
Photo 3. The tunnel from the upper portal loops to the lower portal. This is as far as I went in the tunnel.

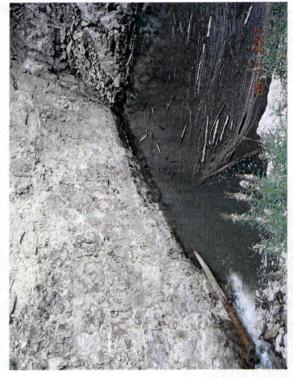
This mine site is in a limestone sink hole along Pole Creek. The creek flows into the sink hole, but there is no surface outlet. I understand the hole sometimes fills to the point the portals are inaccessible until late summer and that they stay under water all summer in some years. I also understand the operator would like to dig near the bottom of the sink hole but that this is impossible in all but the driest years.

Photo 4. There is no surface outlet for the stream.
